Sandia National Laboratories

date: May 26, 2005

subject: Review of Rocket Motor Fires at Umatilla Army Depot

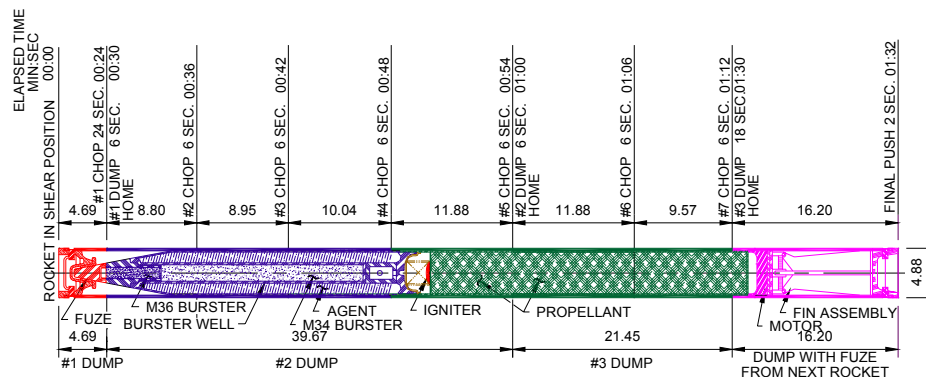
The demilitarization is performed inside an unmanned room which is monitored remotely and is pseudo autonomous, with manual override during some stages. The munition is initially brought into the facility and loaded on a conveyor system. At the first station, the warhead is punched and drained of chemical contents. The next station shears the munition with a vertical shear blade into 8 sections as follows: the first shear removes the nose/fuse section; the next two shear cuts separate the warhead section into pieces. The fourth shear separates the motor from the last warhead section. The fifth through seventh shear operations separate the propellant into 3 sections. Finally the tail section is pushed out of the shear block. Each fire event reviewed on 5/11 occurred during shear 5, the first propellant cut. See the Rocket Detail below.
